## SURFACE WATER DRAINAGE STRATEGY STANWAY VILLAGE HALL, VILLA ROAD, COLCHESTER, CO3 0RH

For Stanway Parish Council

Report Number: YEX1714 Date: May 2021

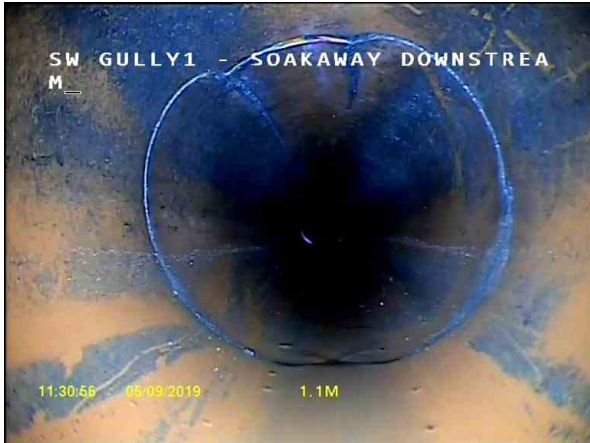
SW GULLY  
 1X\_238bee7b-0ef1-40b3-94d9-e45fabb36af1\_20190916\_151849\_054.jpg, , 1.10m  
 Crack, circumferential from 12 o'clock to 12 o'clock

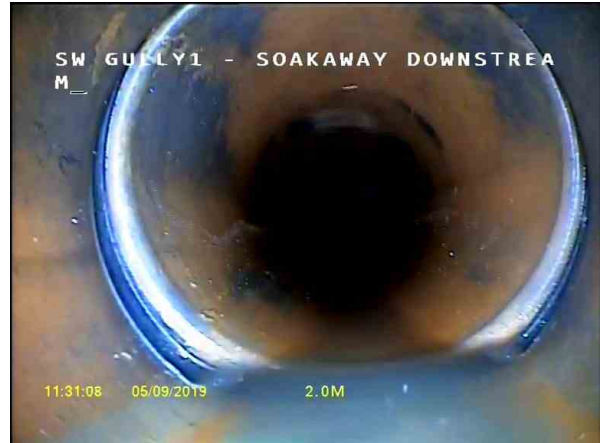
SW GULLY  
 1X\_14c15926-64c0-4188-8db2-6eada36f77c6\_20190916\_151855\_328.jpg, , 2.00m  
 Joint displaced, large

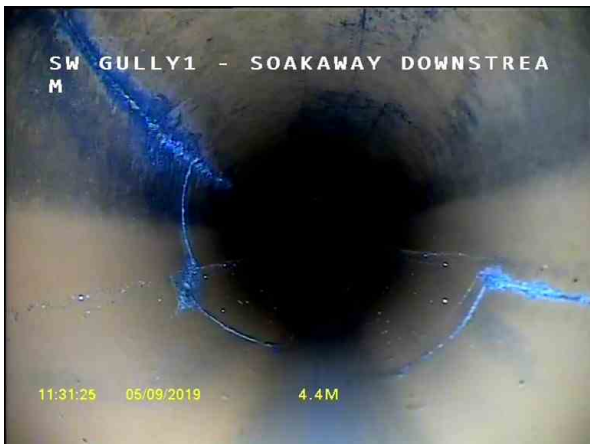
Section	PLR	Grade	Description
1	SW GULLY 1X	3	Cracks, multiple from 12 o'clock to 12 o'clock

SW GULLY  
 1X\_2ca956ba-7540-4b97-a6e8-a268fb3c04a2\_20190916\_151901\_037.jpg, , 4.40m  
 Cracks, multiple from 12 o'clock to 12 o'clock

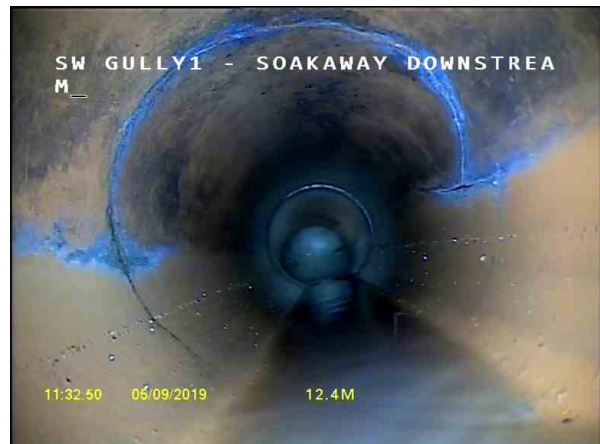
SW GULLY  
 1X\_e573fd1b-45e8-46a8-8456-2c3663eb2edc\_20190916\_151921\_263.jpg, , 12.40m  
 Crack, circumferential from 12 o'clock to 12 o'clock

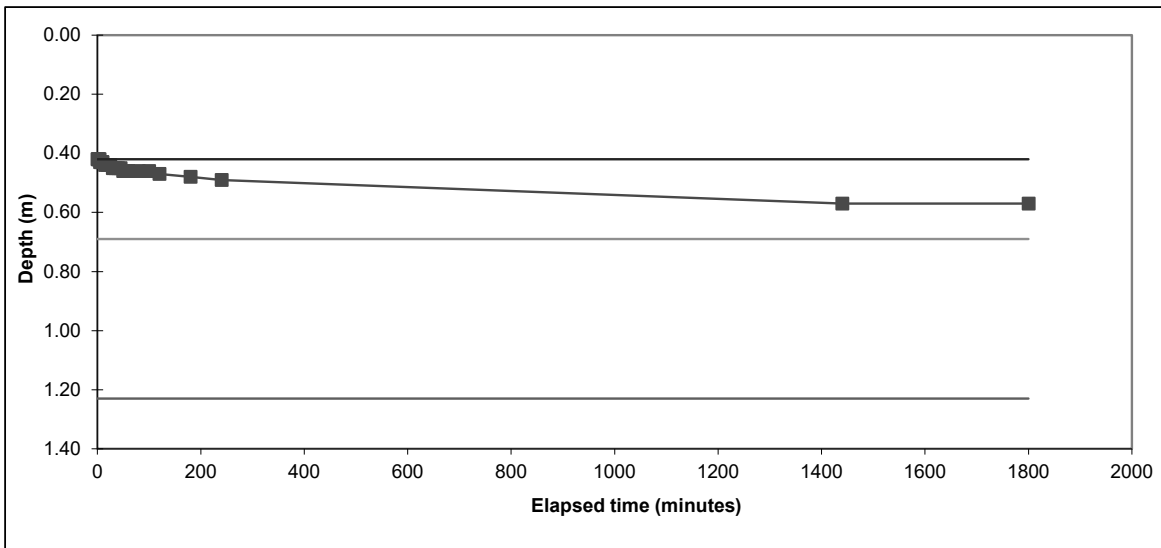
Trial Pit No:	TP1	Test No:	1	Date:	11/03/2021
Length (m):	1.400	Datum Height:		0.00 m agl	
Width (m):	0.30	Granular infill:	None		
Depth (m):	1.50	Porosity of infill:	1	(assumed)

During the soakaway tests the water failed to achieve a fall from 75% to 25% of the effective depth of the storage volume in TP01. The results obtained from the soakaway tests are summarised below:

<b>Soil infiltration rate (m/s):</b>	<b>Test incomplete as 25% effective depth not achieved. Unable to reliably determine soil infiltration rate.</b>
--------------------------------------	--
