## SURFACE WATER DRAINAGE STRATEGY STANWAY VILLAGE HALL, VILLA ROAD, COLCHESTER, CO3 0RH

For Stanway Parish Council

Report Number: YEX1714 Date: May 2021

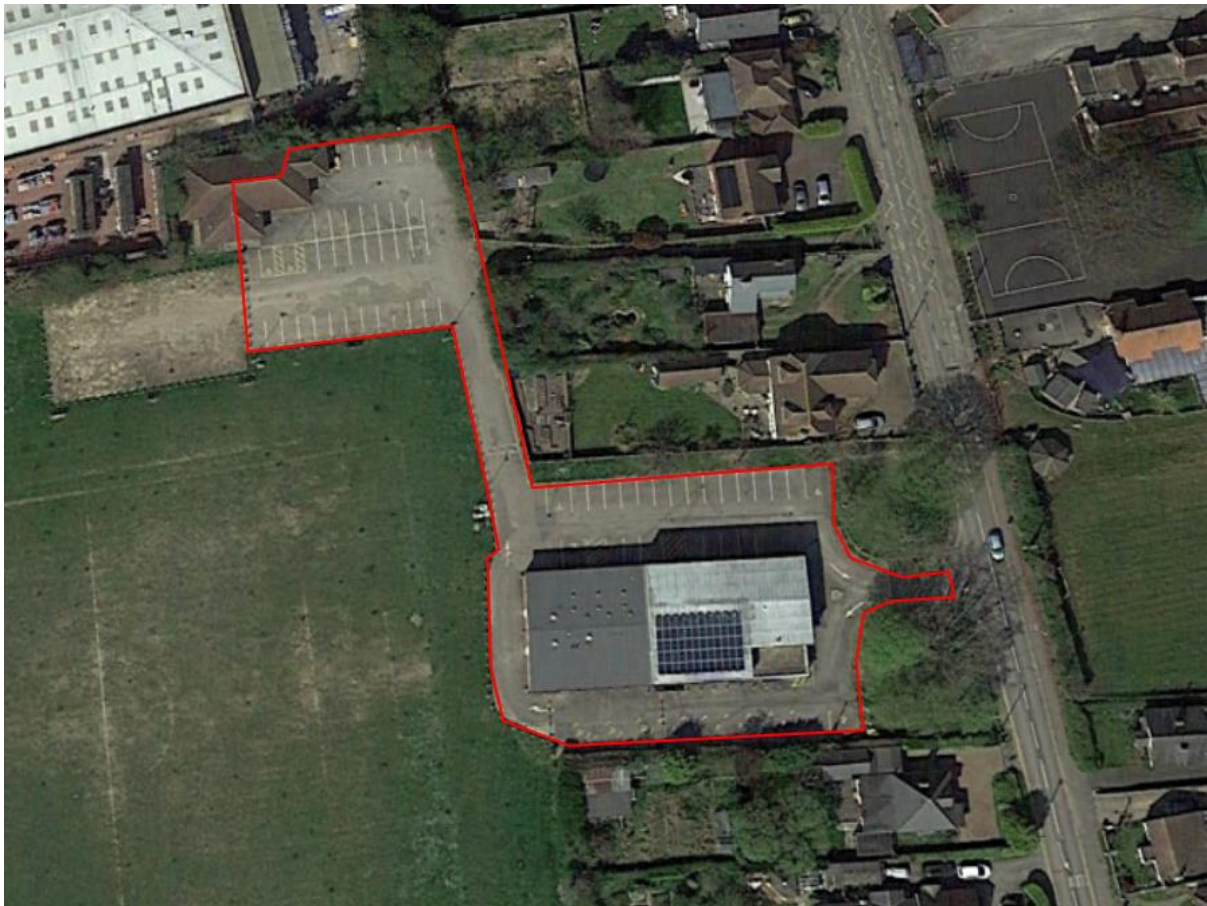
**Figure 1: Location of the site**

An image of the site from Google Earth is provided in Figure 1 below with the area of hardstanding which is assumed to drain to soakaways outlined in red.
